**PROSPECT
PROPERTIES**
Home Inspections

Inspection Report For:
Bob and Carol Sample

Property Inspected:
10120 Oak Lane
Glen Allen, VA 23059

Date Inspected: November 1, 2018

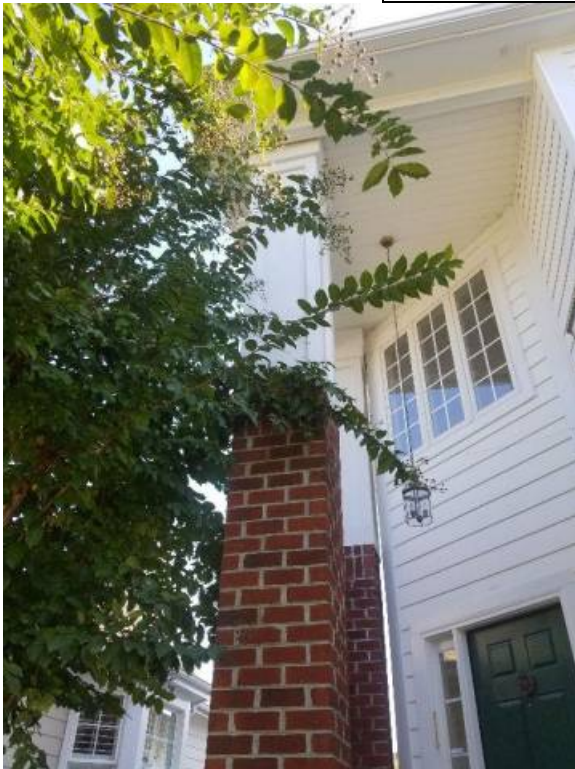
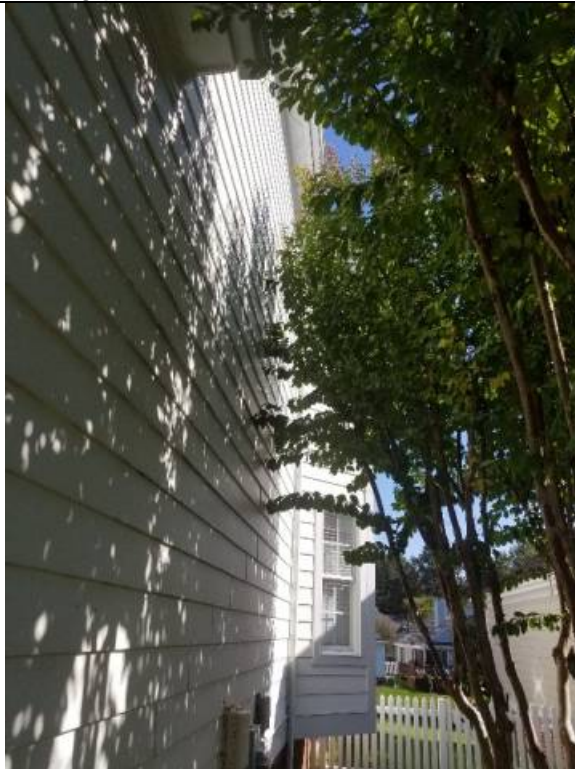
CONDITION:	Recommend trimming plants/trees away from structure.
------------	--

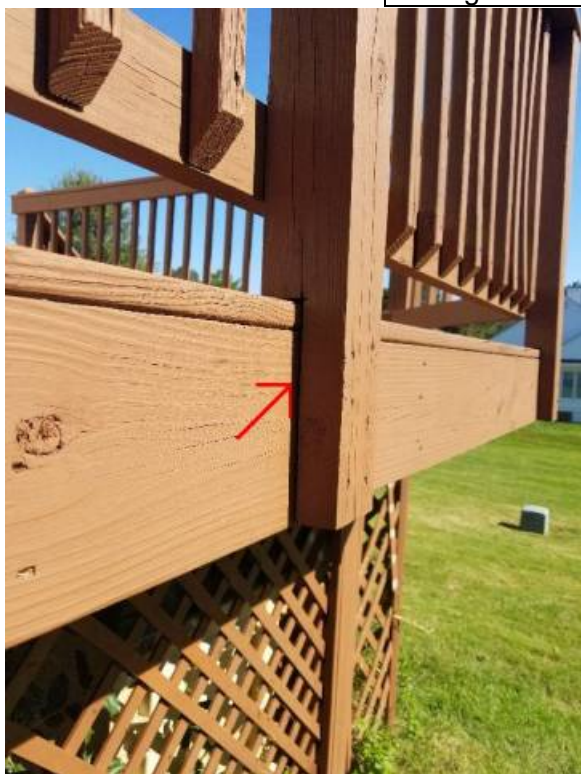
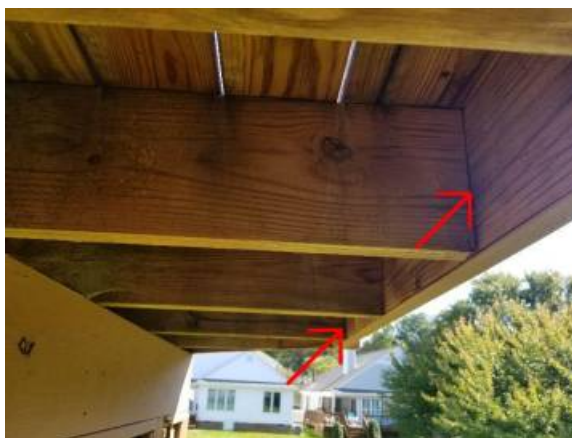
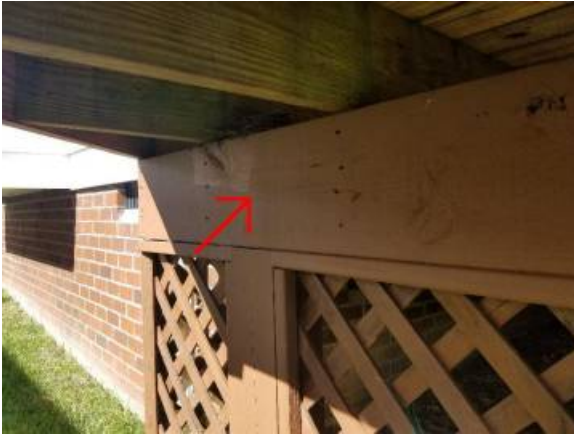
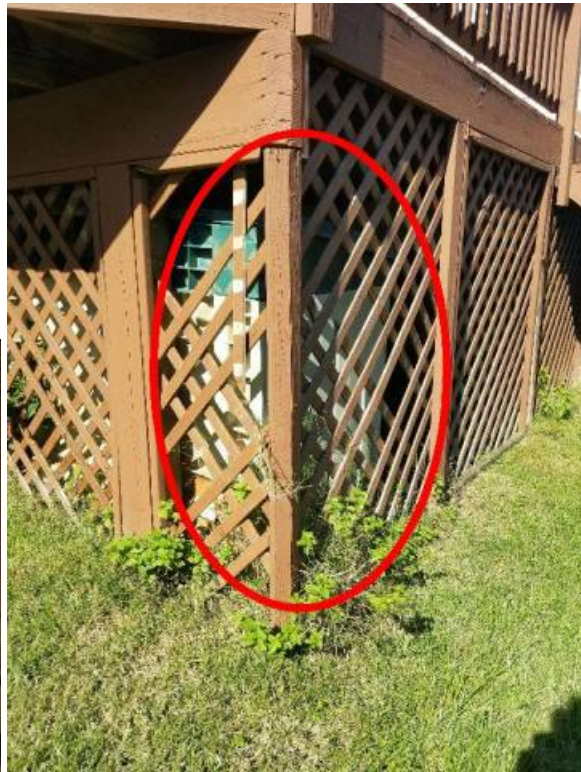
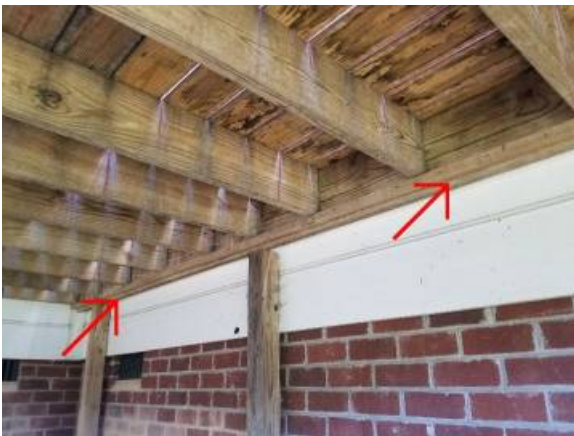
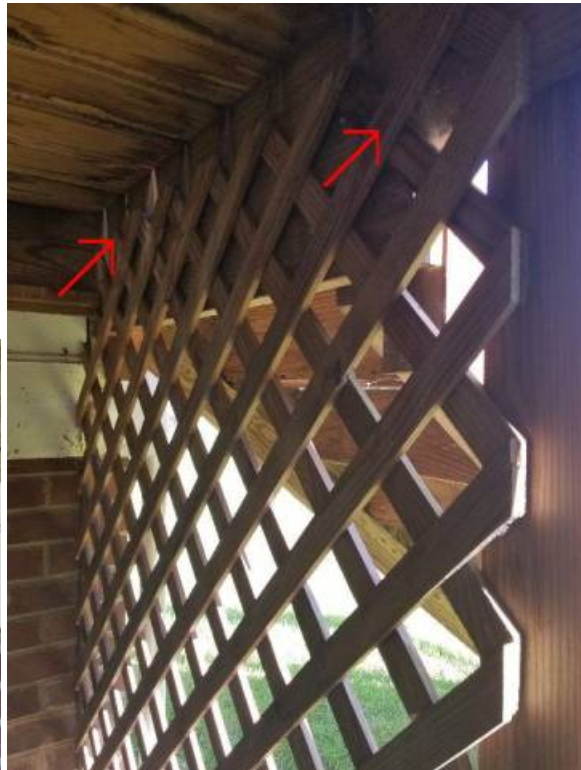
Straps or brackets need to be installed at the stair stringers. The posts for the handrails have been notched. This weakens the posts and is no longer permitted due to safety reasons. Full 4 x 4 posts should be installed to support the handrails. The outer ledger board where the posts are connected are not properly secured to the floor joist. This connection will need to be improved when the new handrail posts are installed. The ledger board against the home is single and is not attached to the deck posts. This ledger board should be doubled and all of the posts and girders need to be secured with bolts. Some of the lattice work on the backside of the deck is damaged and needs to be repaired or replaced.

Straps or brackets need to be installed at the stair stringers. The posts for the handrails have been notched. This weakens the posts and is no longer permitted due to safety reasons. Full 4 x 4 posts should be installed to support the handrails. The outer ledger board where the posts are connected are not properly secured to the floor joist. This connection will need to be improved when the new handrail posts are installed. The ledger board against the home is single and is not attached to the deck posts. This ledger board should be doubled and all of the posts and girders need to be secured with bolts. Some of the lattice work on the backside of the deck is damaged and needs to be repaired or replaced. **\$800 - 950.**

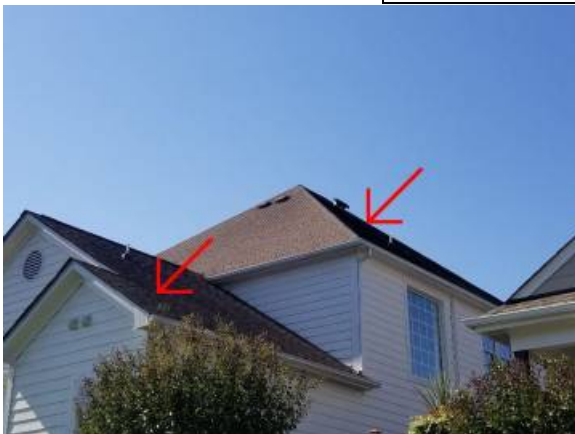
General condition appears serviceable with signs of weathering and granular deterioration. Regular maintenance and inspections are advised. The left side of the roof has some moss growing on it.

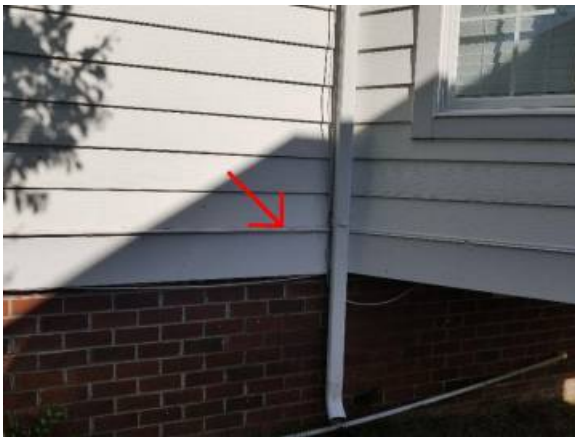
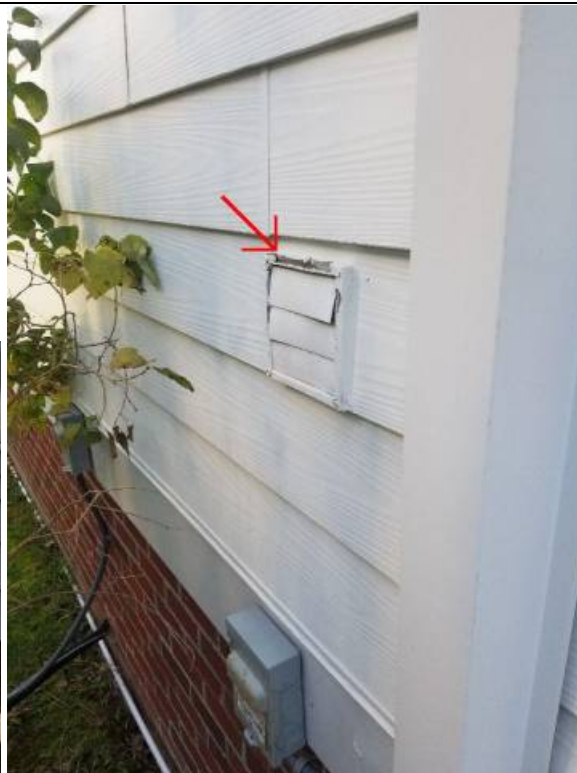
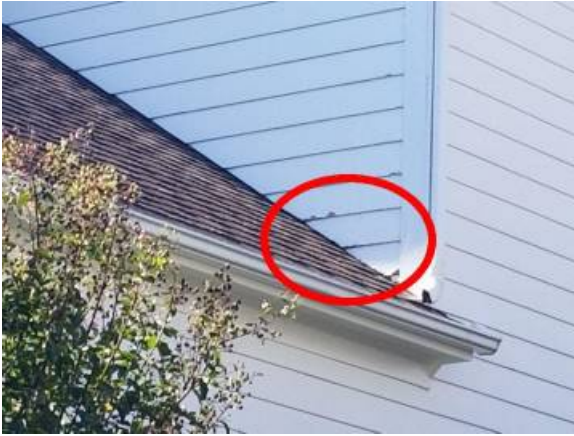
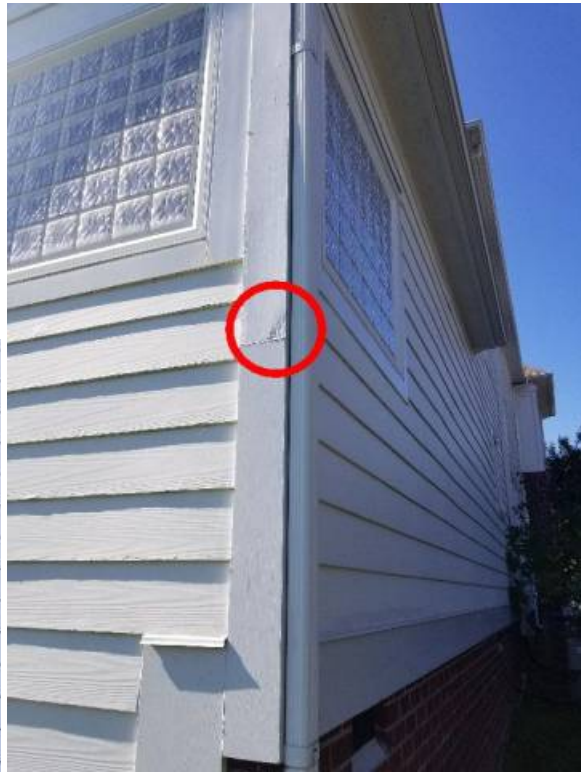
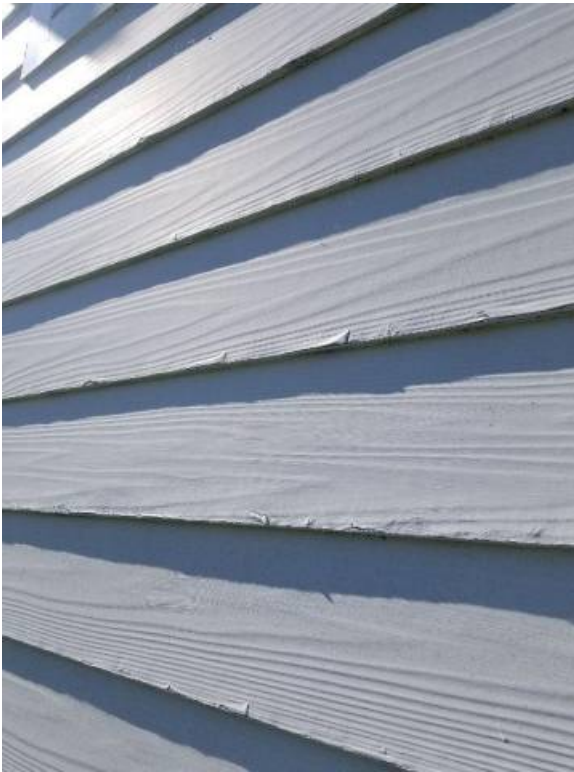
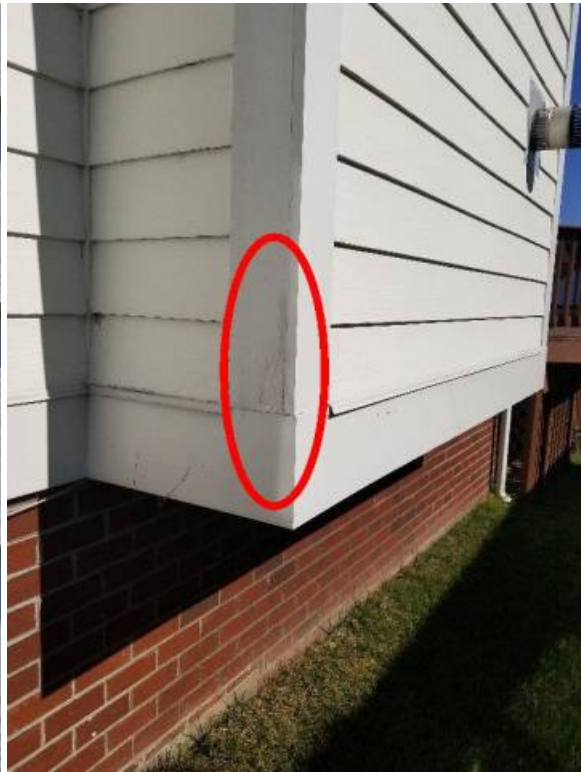
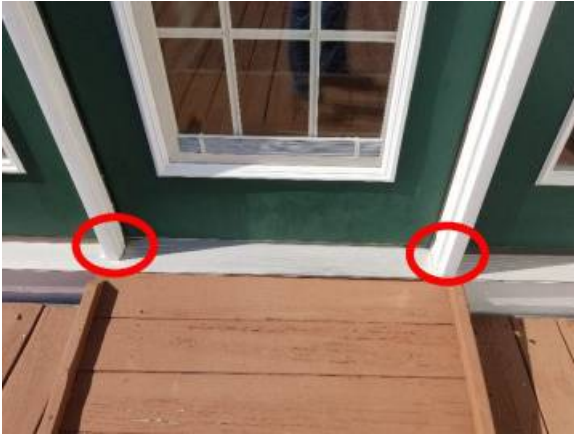
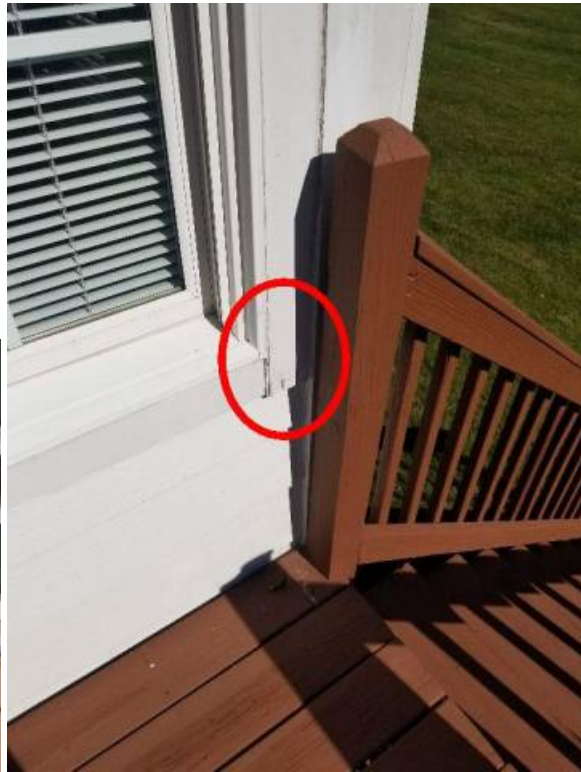
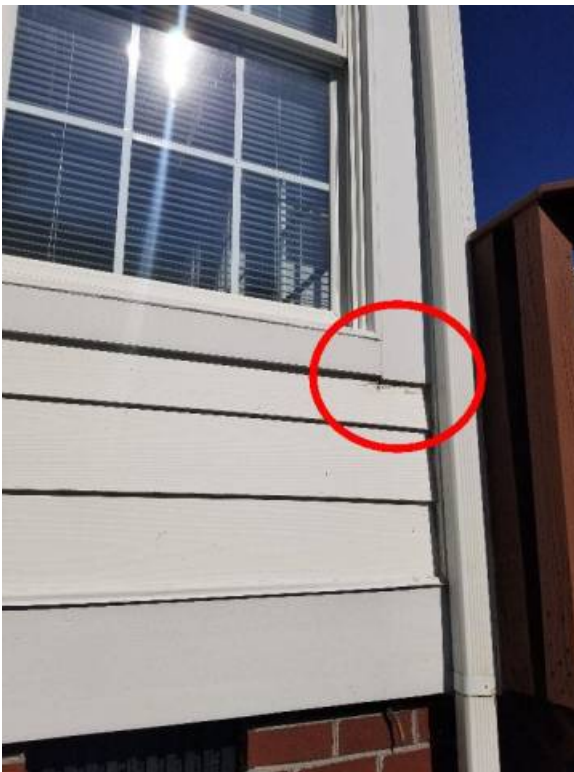
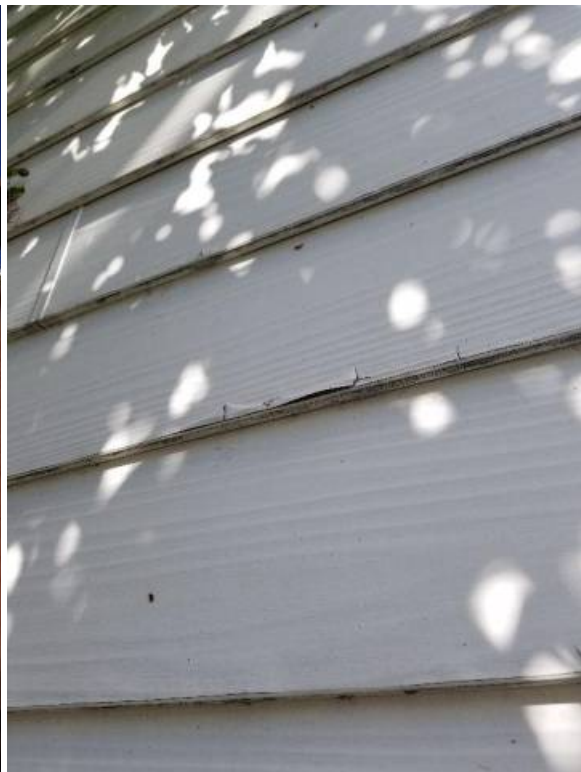
The dryer vent is damaged on the left side of the home. Moisture damage observed at the following areas: trim on the left side of the fireplace bump out, siding under the right side rear family room window, trim at the rear family room door, trim at the window near the deck stairs, corner trim at the left rear corner of the home and three sections of siding on the back of the home above the roof over the master bedroom. Paint/finish is needed in many areas.

The dryer vent is damaged on the left side of the home. Moisture damage observed at the following areas: trim on the left side of the fireplace bump out, siding under the right side rear family room window, trim at the rear family room door, trim at the window near the deck stairs, corner trim at the left rear corner of the home and three sections of siding on the back of the home above the roof over the master bedroom. **\$875 - 1,000.**

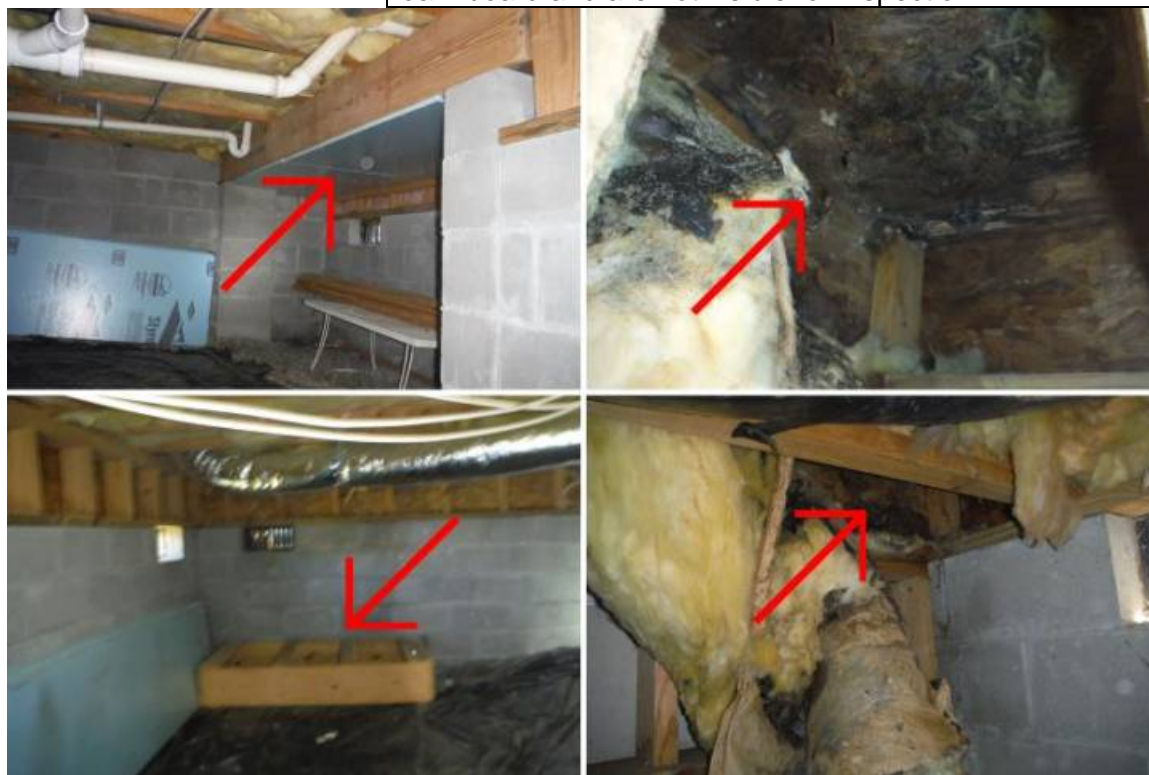
CONDITION: Recommend removing wood debris and trash from the crawl space area. Significant moisture damage observed at the subfloor in the right rear corner of the crawl space under the family room. It appears the rear family room doors are leaking and this has been a long-term issue. Further evaluation by a licensed contractor is needed. These doors may need to be removed to make necessary repairs. Some of the floor joists have been covered with foam board and are not visible for inspection.

Recommend removing wood debris and trash from the crawl space area. **\$50 - 75.** Significant moisture damage observed at the subfloor in the right rear corner of the crawl space under the family room. It appears the rear family room doors are leaking and this has been a long-term issue. **Further evaluation by a licensed contractor is needed.** These doors may need to be removed to make necessary repairs.

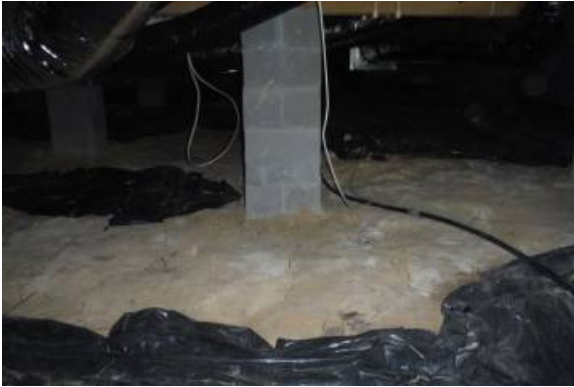
VAPOR BARRIER: Vapor retarder not installed in some areas. Recommend installing 6 mil poly to cover 100% of crawl floor.

Vapor retarder not installed in some areas. Recommend installing 6 mil poly to cover 100% of crawl floor. **\$150 - 235.**

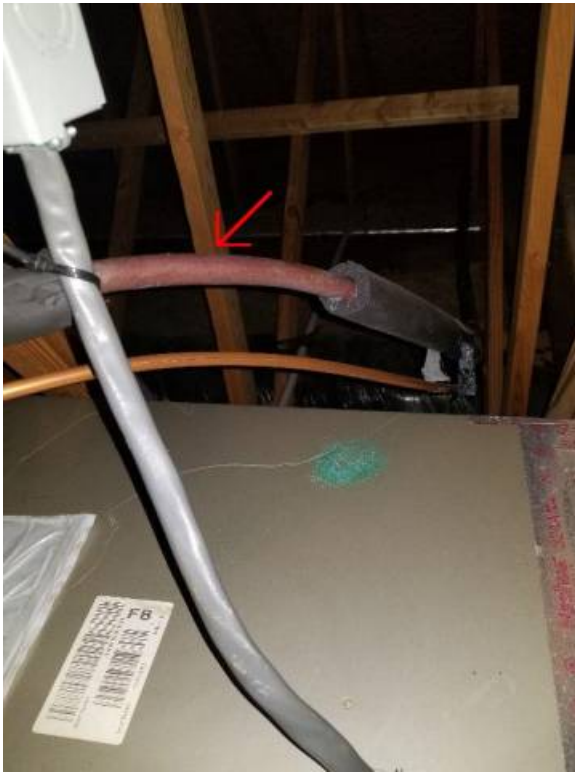
LOCATION OF SECONDARY UNIT:	Attic.
SYSTEM TYPE:	Forced Air, Heat pump.
FUEL TYPE:	Electric.
NOTES:	Missing insulation observed on the line set just above the air handler in the attic.

Missing insulation observed on the line set just above the air handler in the attic. **\$50 - 75.**

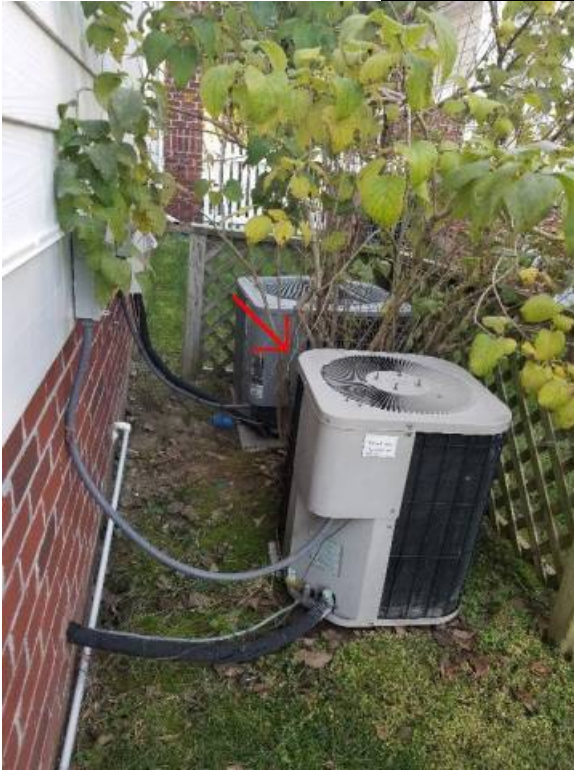
System is at or near the end of its useful life; due to age and general wear that has occurred over the years. Recommend clearing foliage away from unit. Recommend installing pea gravel around exterior unit to prevent coils from getting dirty.

Recommend clearing foliage away from unit. **\$150 - 200**

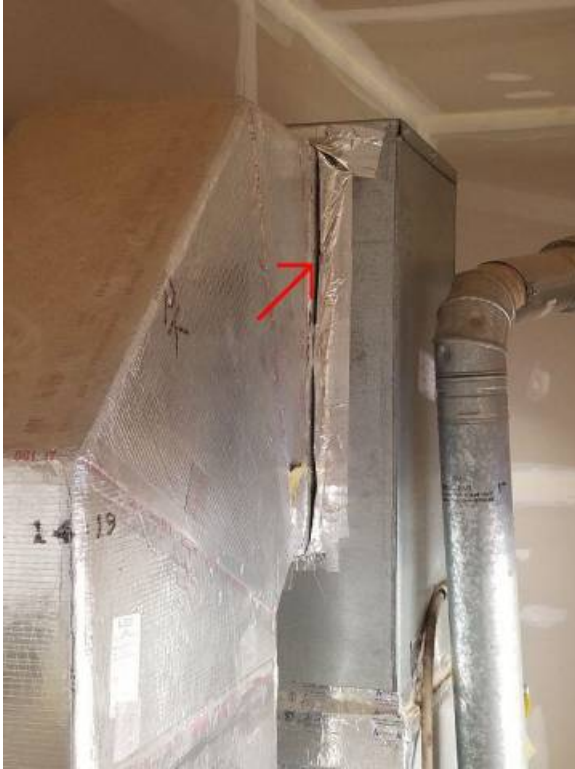
Loose tape observed at the duct work above the furnace.

Loose tape observed at the duct work above the furnace. **\$75 - 125.**

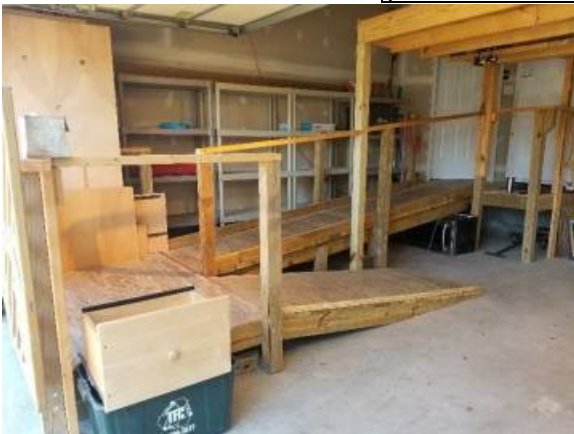
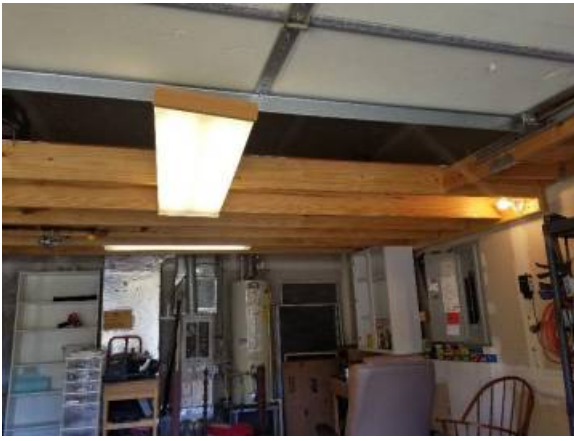
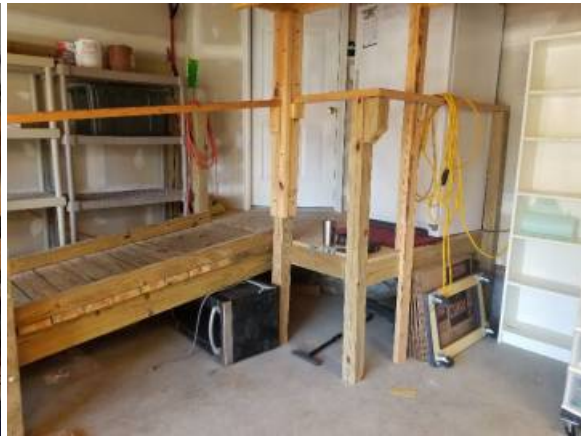
The wooden ramp system is going to be removed and was not inspected. After the ramp has been removed a proper landing and railings will need to be installed with stairs. The storage area that has been constructed in the garage is not constructed or framed to today's building standards. Recommend having improvements made if the storage area is to remain in place.

The wooden ramp system is going to be removed and was not inspected. After the ramp has been removed a proper landing and railings will need to be installed with stairs. The storage area that has been constructed in the garage is not constructed or framed to today's building standards. Recommend having improvements made if the storage area is to remain in place.

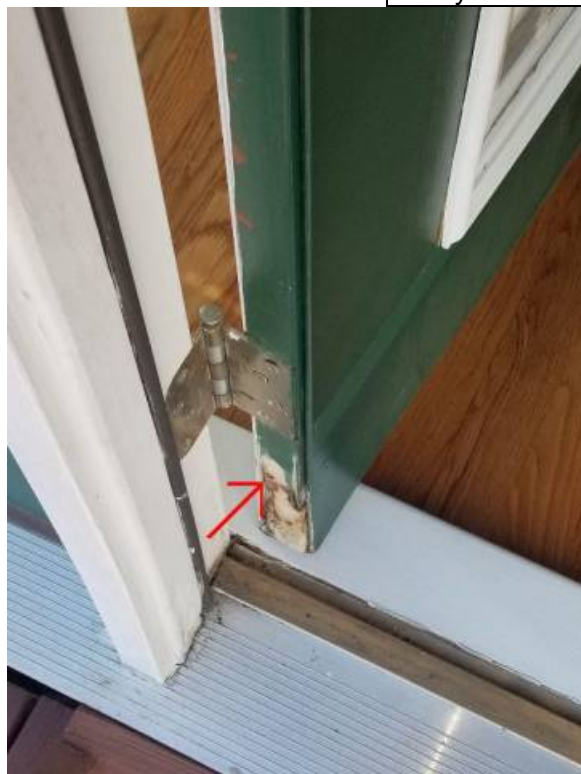
The rear family room door rubs and sticks and needs to be adjusted. Evidence of past repairs due to moisture damage observed at the rear family room door.

The rear family room door rubs and sticks and needs to be adjusted. **\$50 - 100.**

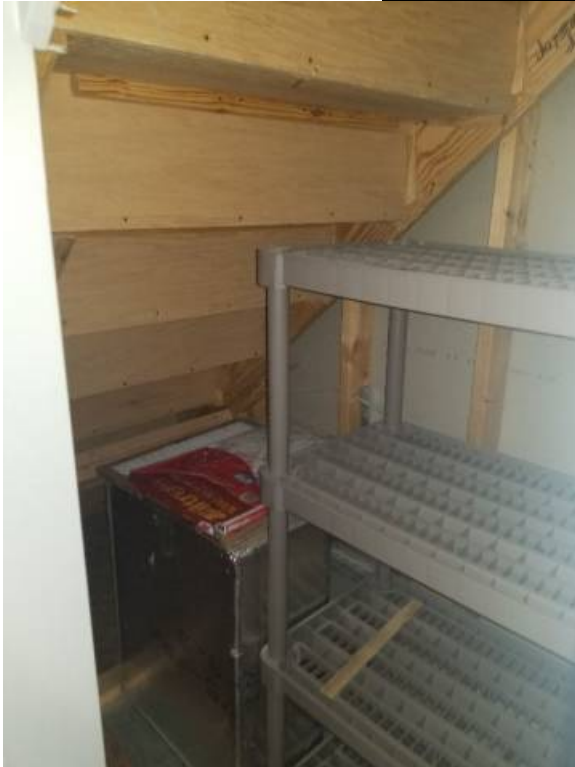
Drywall, Appears functional. Typical cracks are noted. Stored items or furnishings prevent full inspection. The area that has been opened under the staircase in the laundry room needs to be closed off or sheetrock needs to be installed to cover the exposed framing and electrical wiring.

The area that has been opened under the staircase in the laundry room needs to be closed off or sheetrock needs to be installed to cover the exposed framing and electrical wiring. **\$150 - 375.**

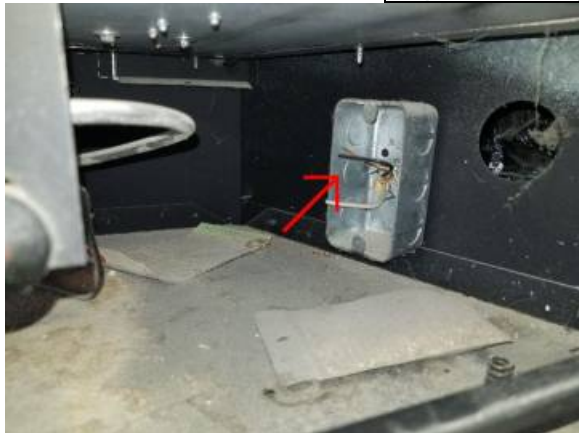
Exposed wiring observed under the fireplace.

Exposed wiring observed under the fireplace. **\$75 - 100.**

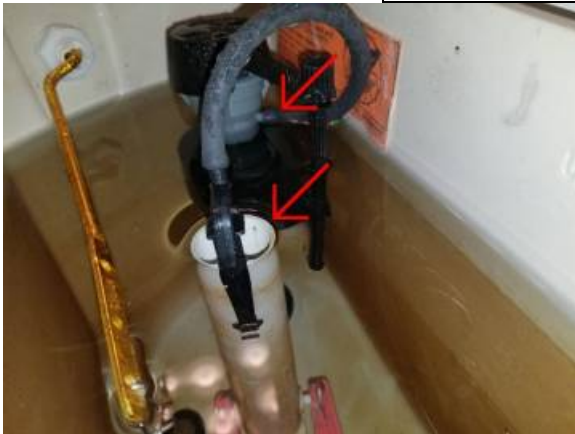
BATH LOCATION:	Hall - 1st floor.
CONDITION OF SINK:	Appears functional.
CONDITION OF TOILET:	The fill valve is located below the overflow tube. This can cause cross contamination of water which is a health hazard.

The fill valve is located below the overflow tube. This can cause cross contamination of water which is a health hazard. **\$75 - 150.**

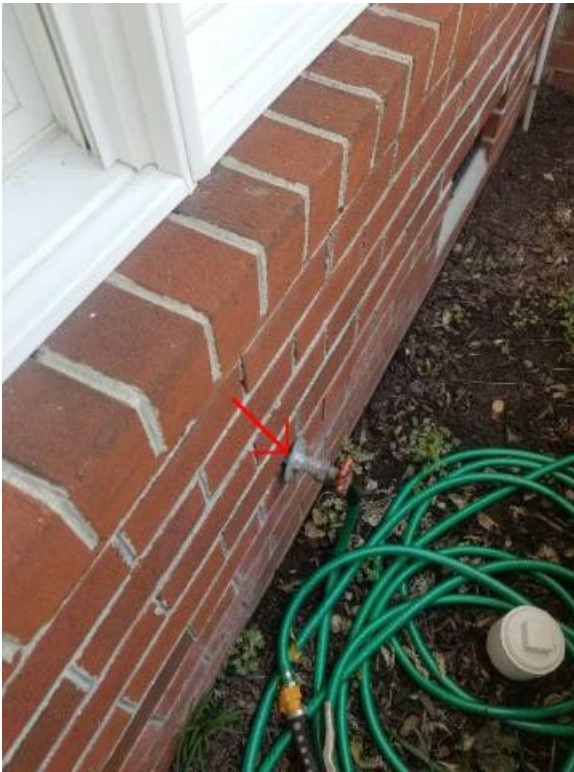
OPERATION: The front faucet is not secured to the foundation.

The front faucet is not secured to the foundation. **\$50 - 100.**

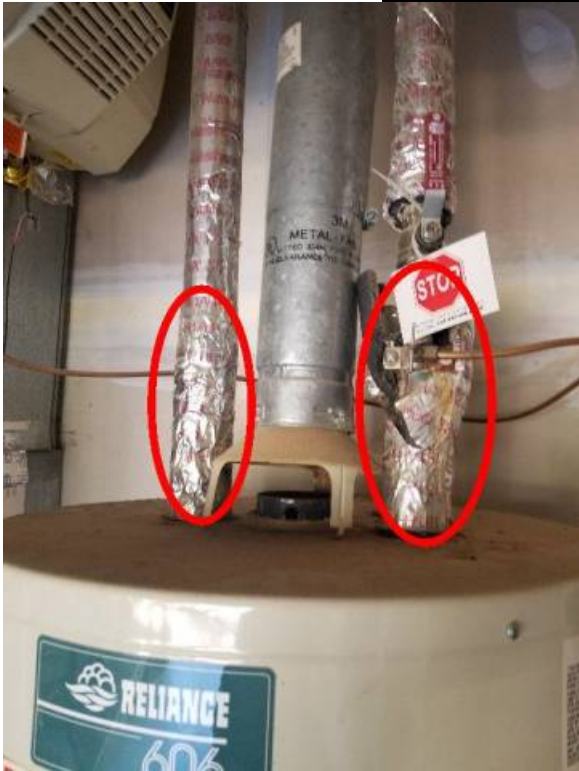
LOCATION:	Garage.
CONDITION:	Unit is at or near the end of its useful life; due to age and general wear that has occurred over the years. 2000. Insulation around water pipes above water heater needs to be removed so that there is 6 in of clearance between it and the flue opening at the top of the water heater.

Insulation around water pipes above water heater needs to be removed so that there is 6 in of clearance between it and the flue opening at the top of the water heater. **\$25 - 50.**

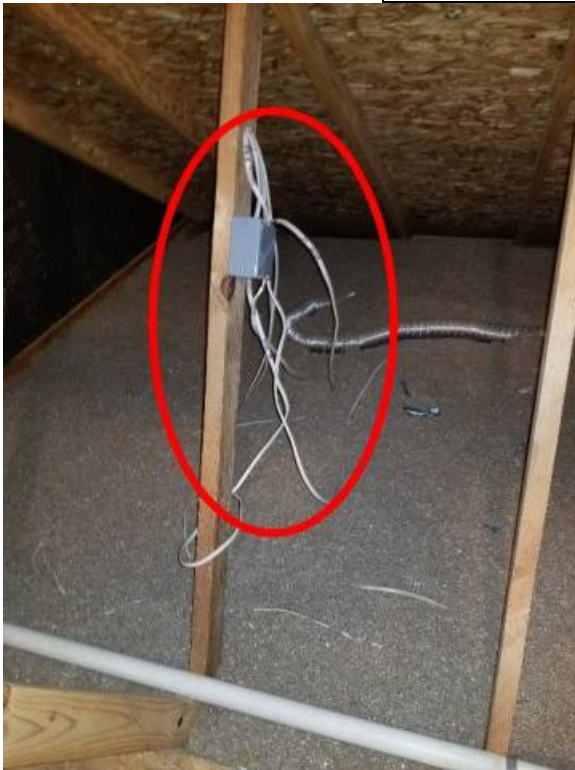
Copper. Aluminum (220 volt OK). Wire is partially/largely hidden from view. Unsecured wiring observed in the rear attic area.

Unsecured wiring observed in the rear attic area. **\$50 - 75.**

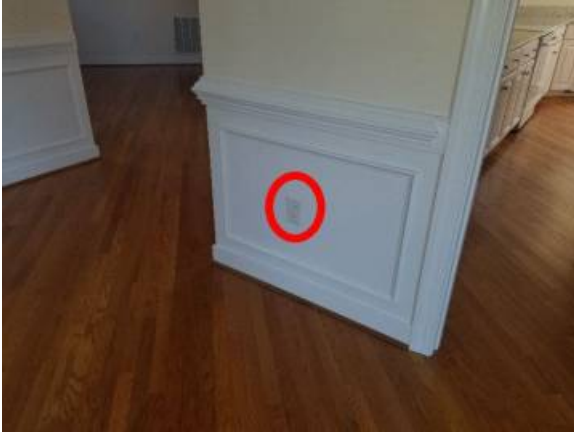
A representative sampling of switches and outlets was tested. As a whole, outlets and switches throughout the house are functional. The function of some switches could not be determined. The GFCI outlet in the foyer is not working properly. Lights are not operational in some areas, possibly due to bad bulbs.

The GFCI outlet in the foyer is not working properly. **\$75 - 125.** The function of some switches could not be determined. Lights are not operational in some areas, possibly due to bad bulbs.
