**PROSPECT
PROPERTIES**
Home Inspections

Inspection Report For:
Bob and Carol Sample

Property Inspected:
10120 Oak Lane
Glen Allen, VA 23059

Date Inspected: November 1, 2018

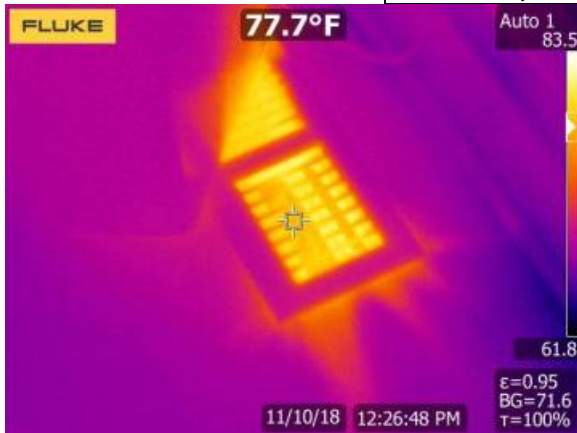
LOCATION OF PRIMARY UNIT:	Garage.
SYSTEM TYPE:	Forced Air.
FUEL TYPE	Natural Gas.
DESCRIPTION:	A gas fired warm air furnace uses natural gas or propane burned in an open or sealed chamber to heat an exchanger, and with the help of a blower or fan, moves air across the exchanger into ductwork to heat the space.
NOTES	Good temperature differential observed in the heating mode.

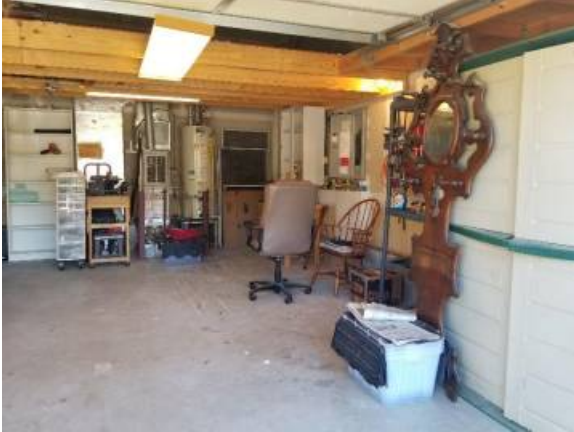
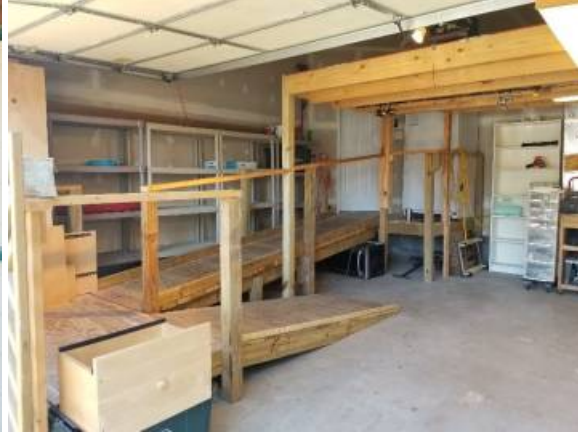
CONDITION: Floor is not fully visible due to stored items.

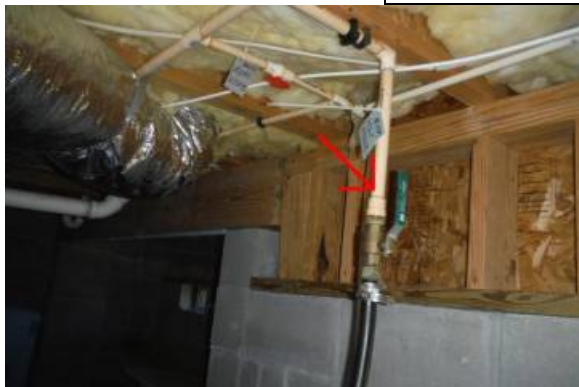
LOCATION OF MAIN VALVE: Main water valve is located in the crawl space.

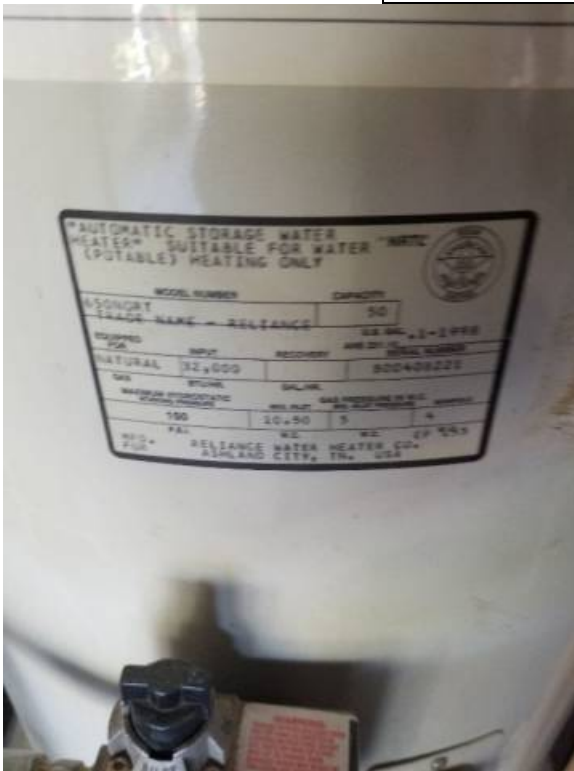
LOCATION:	Garage.
CONDITION:	Unit is at or near the end of its useful life; due to age and general wear that has occurred over the years. 2000. Insulation around water pipes above water heater needs to be removed so that there is 6 in of clearance between it and the flue opening at the top of the water heater.

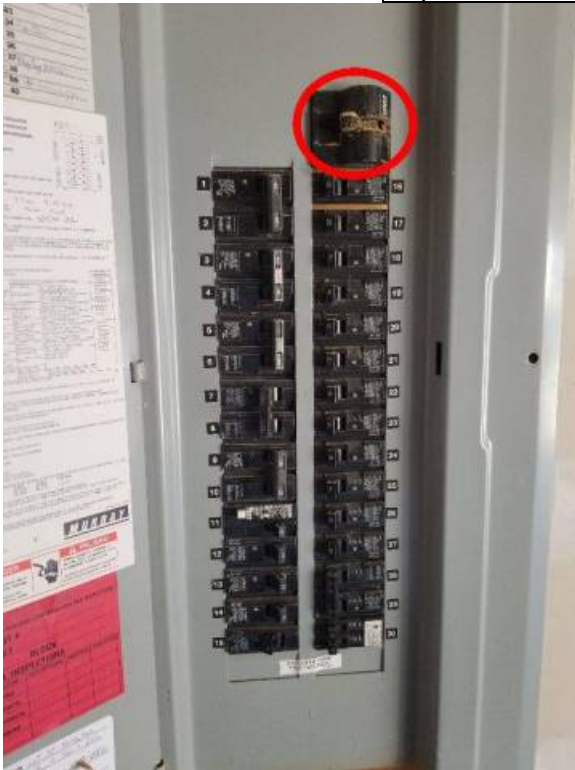
MAIN PANEL LOCATION AND NOTES: Garage.

MAIN DISCONNECT: Location:
In panel box.
